Participatory Evaluation of Performance in Public Buildings. The Case of Historic Buildings of the Ministry of Public Works, Chile.

Gabriela Armijo^{#1}, Eugenio Collados^{*2}, Patricio Bustamante^{*3}

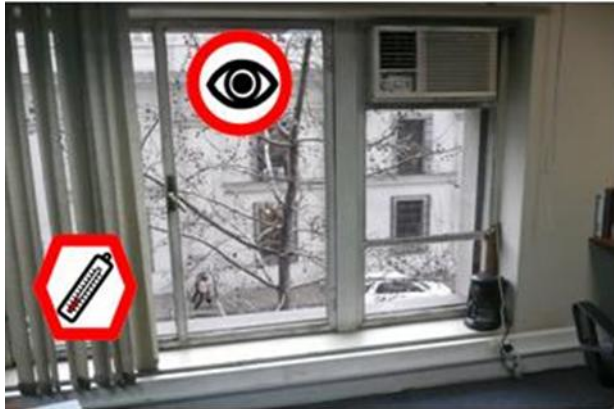
Figure 3: Example of recording visual and cold problems.

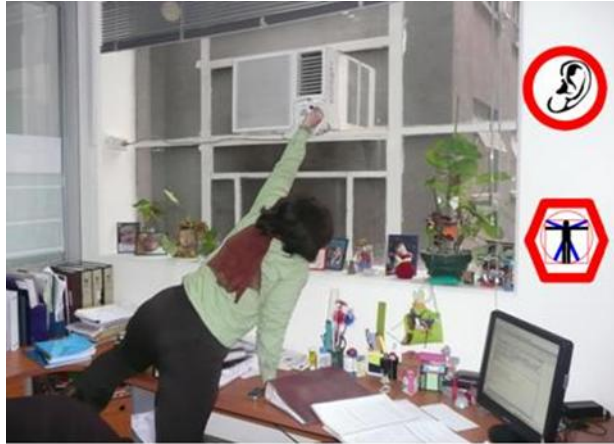
Figure 4: Example of recording noise and ergonomic problems.

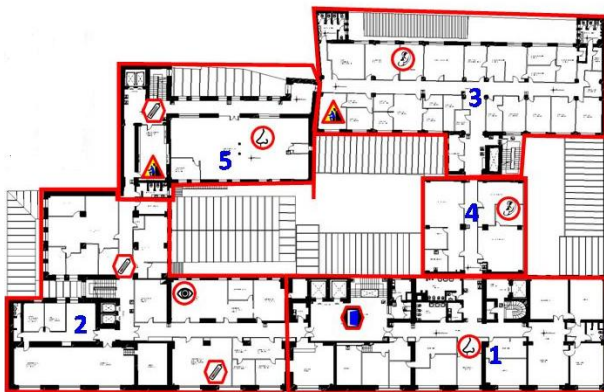
Figure 5: Example of symbols location in a floor-plan.

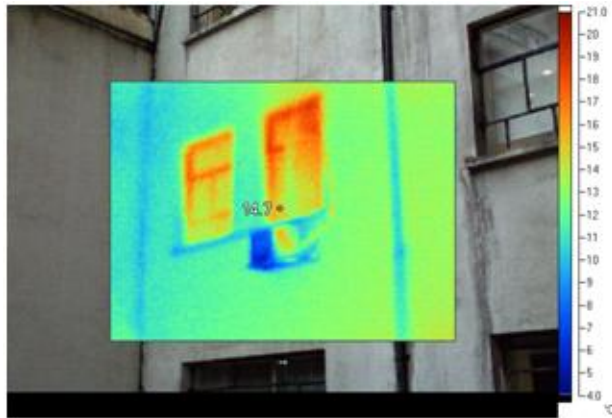
Figure 8: Example of thermal image of uncontrolled heated air leaking through windows.

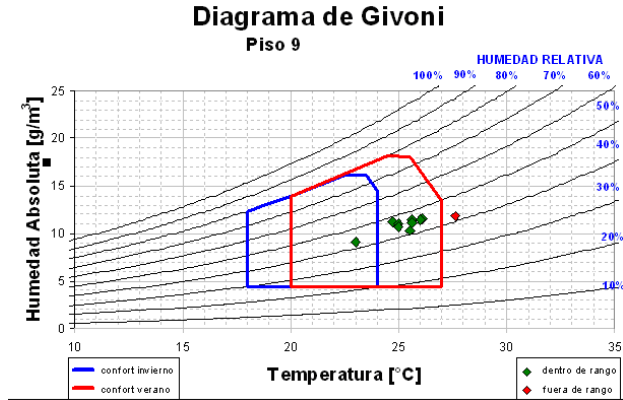
Data from temperature and humidity measurements were also graphed in Givoni diagrams [4], in order to better describe the comfort ranges to users. Most places showed conditions within comfort range, which remarkable for a building having poor HVAC systems and relies mostly on a large thermal mass, very effective in the climate of Santiago de Chile. Only a few places showed overheating.

Figure 9: Example of Givoni diagram for 10 samples taken at 10 workstations on the 9th floor.

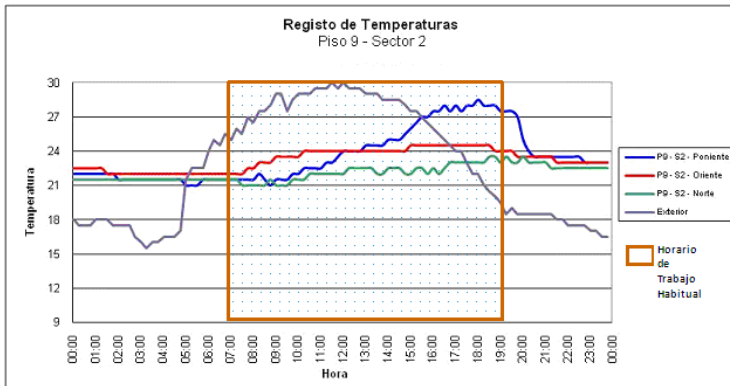
Figure 10: Recording of temperatures at several positions in 9th floor (Summer).
