# Post-Occupancy Evaluation of State Schools in 5 Climatic Zones of Chile

This paper presents the results of a study, commissioned by the Chilean Ministry of Education and UNESCO, of hygro-thermal comfort, visual comfort, acoustics and indoor air quality, as experienced in selected classrooms of 8 state schools located in distinct climatic zones in Chile.

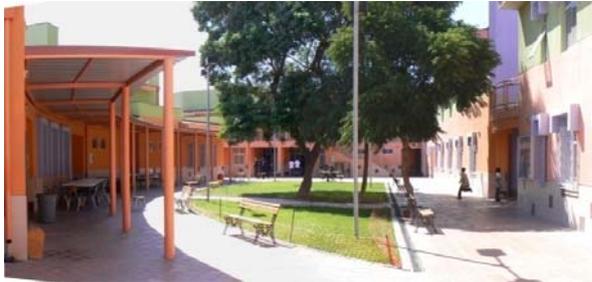
The school is situated with the main road to the north and a side road to the east. The classroom is on the ground floor, facing east. The construction is reinforced concrete, of 250mm overall thickness with a pale green painted plaster internal finish and external un-insulated render. The room is 2.9m high with 17.8% of the wall surface glazed, principally towards the east. No external solar protection is provided with only internal curtains. The artificial lighting consists of 16 fluorescent tubes, which are all switched on.

Figure 2. School A, External view

At an urban scale the offending lorries could be redirected via an alternative route, or prohibited during school hours. Otherwise the use of hermetically sealed double glazing with mechanical ventilation should be considered.

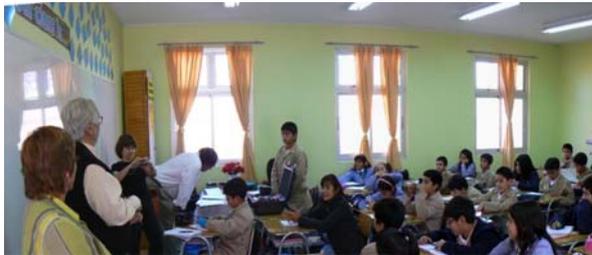
Figure 3. School A, Internal view of study classroom

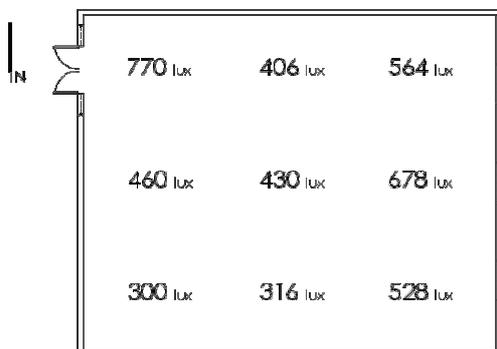
Figure 4. School A, illumination at desk level

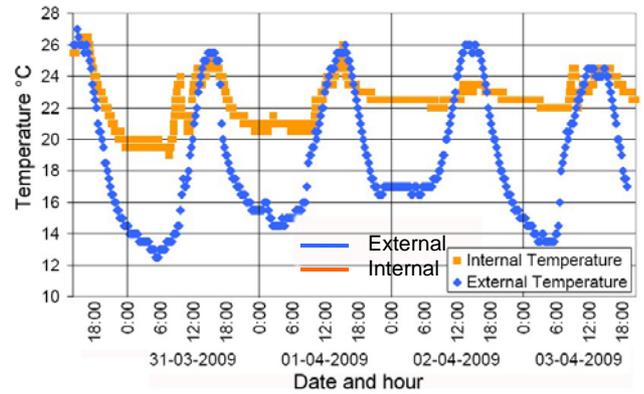
Figure 5. School A, Internal and external temperatures over a 4 day period

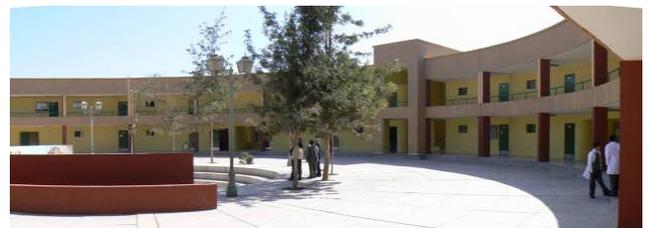
The school is situated within its own grounds. To the west, the direction of the predominant wind (SW), is located a bare earth football pitch. The classroom is situated on the ground floor, facing north. The construction is reinforced concrete, of 270mm overall thickness with a pale yellow painted plaster internal finish and external un-insulated render. The room is 2.7m high with 17% of the wall surface glazed, principally towards the North. No external solar protection is provided with only internal curtains. The artificial lighting consists of 14 fluorescent tubes, which are all switched off.

Figure 6. School B, External view

Teachers interviewed reported that the location of the bare earth football pitch causes problems with dust and prohibits the opening of windows. The simplest solution would be to surface the pitch or create a windbreak with trees and shrubs.

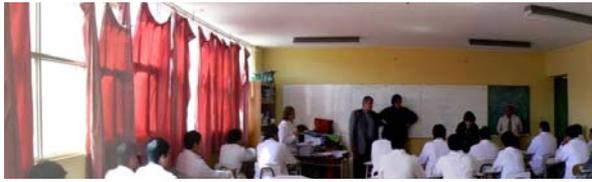
Figure 7. School B, Internal view of study classroom

A third of teachers interviewed experienced discomfort from glare arising from the lack of external solar protection. In turn this leads to internal curtains often being closed, thus reducing natural daylighting and augmenting the reliance on artificial illumination.

Horizontal shading, perhaps in the form of a light shelf could reduce glare and provide more homogeneous daylighting.

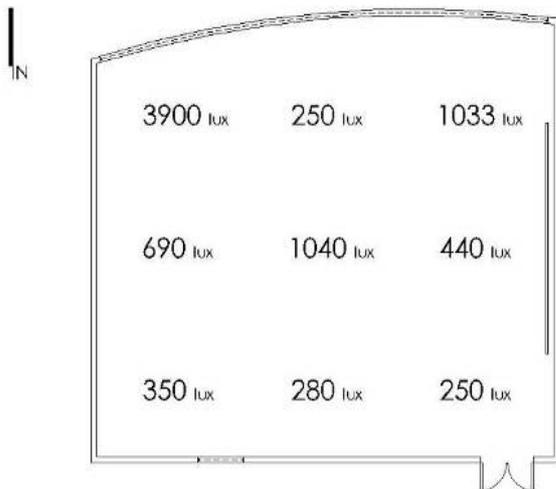
Figure 8. School B, illumination at desk level

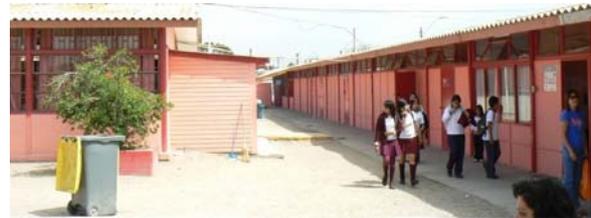
The school occupies an entire urban block in the town centre. The classroom is situated on the ground floor, facing west. The construction is a steel frame with un-insulated 90mm brick, or 40mm solid panel infill. The internal finish is apricot painted plaster. The room is 2.7m high with 17% of the wall surface glazed, principally towards the west. Planting provides limited external solar protection, supplemented by internal curtains. The artificial lighting consists of 4 low energy pendant bulbs, which are all switched on.

Figure 9. School C, External view

School C again suffers similar problems regarding noise pollution, leading to poor ventilation, in addition to lack of solar protection.

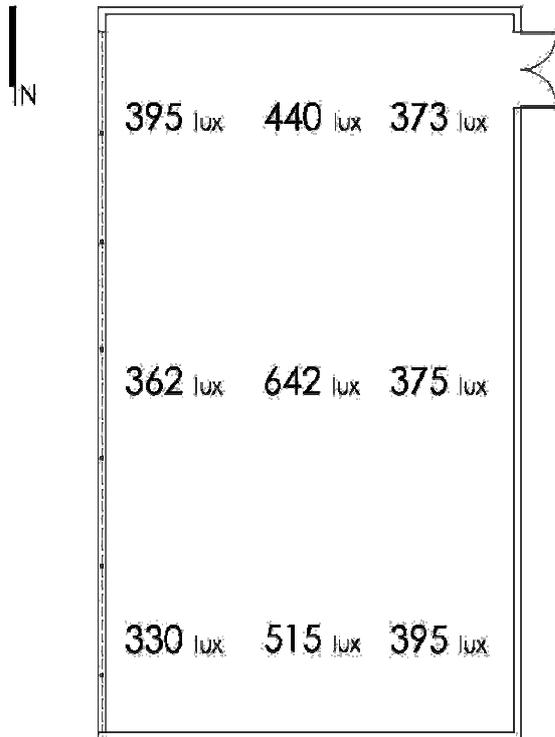
Figure 11. School C, illumination at desk level

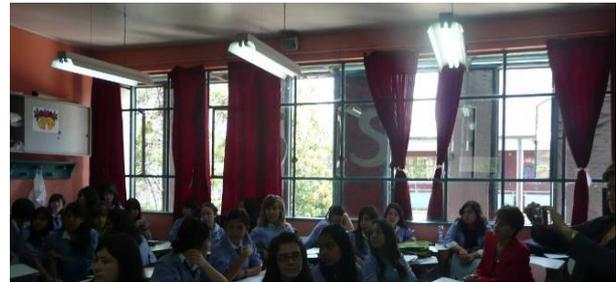
Figure 14. School D, Internal view of western classroom

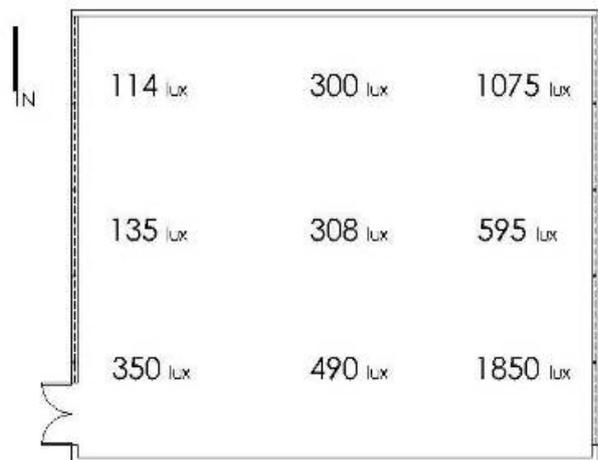
Figure 15. School D, illumination at desk level  
Eastern Classroom

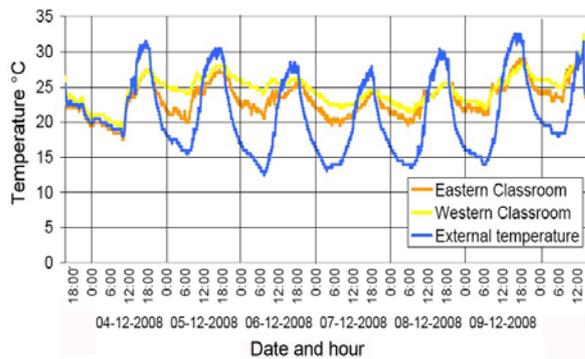
Figure 16. School D, Internal and external temperatures over a 6 day period

Once again, due to the schools city centre location, noise pollution is the principal problem faced by school D. Of the teachers interviewed all reported that background noise levels interfere with their work. They confirmed a constant conflict between external noise when windows are open and poor indoor air quality and serious overheating when windows remain closed.

The complexity of the inner-city location would make urban transport control an unlikely solution, therefore hermetic high performance glazing with mechanical ventilation could perhaps be the most appropriate solution. This could be coupled with the use of night purging to take advantage of the low nocturnal temperatures experienced in Santiago, and the high thermal mass inherent in the buildings construction, to help reduce summer peak temperatures.

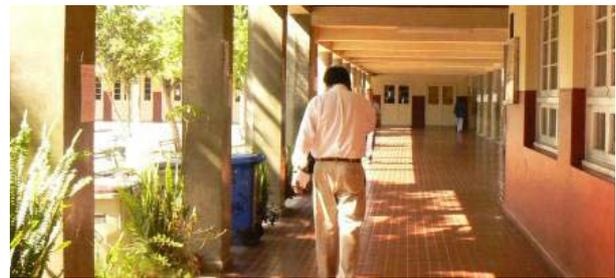
The school is situated in a quiet residential neighbourhood fronting onto a square. The classroom is situated on the ground floor facing north. The construction is solid brick, of 250mm overall thickness with an apricot painted plaster internal finish and external un-insulated render. The room is 3.2m high and has 17% of wall surface glazed, distributed equally between external wall and that to the internal patio. No external solar protection is provided with only internal curtains. The artificial lighting consists of 6 fluorescent tubes, the lights are all switched on.

Figure 17. School E, External view

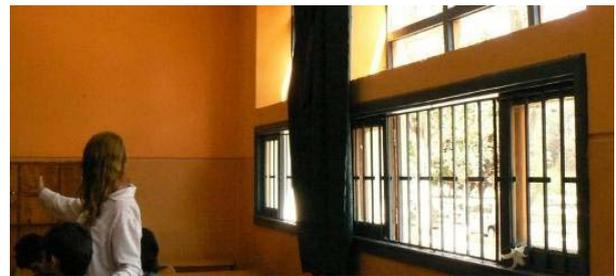
Figure 18. School E, Internal view of study classroom

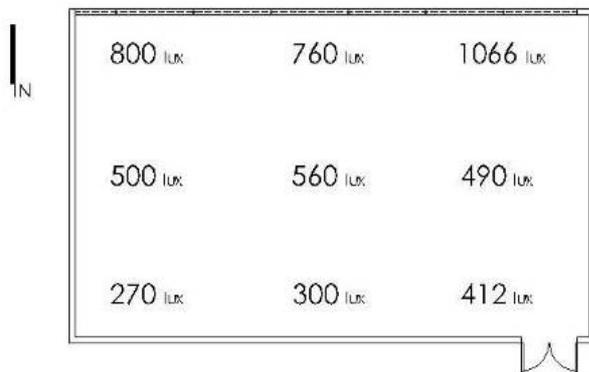
Figure 19. School E, illumination at desk level

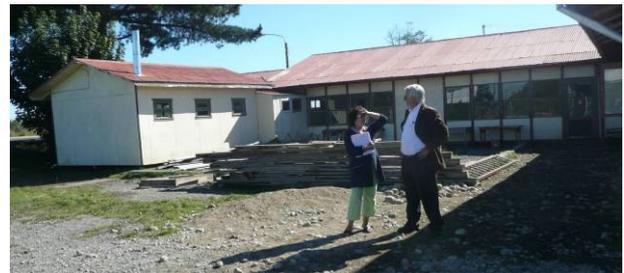
The school is situated in a rural location but is adjacent to the cities airport. The classroom is situated on the ground floor, facing north. The construction is timber framed with un-insulated timber panel infill painted pale yellow internally. The windows are fixed shut due to noise pollution from adjacent airport. No external solar protection is provided with only internal curtains. The artificial lighting consists of fluorescent tubes, which are all switched off.

Figure 20. School F, External view

At school F the problem of external noise pollution is taken to its extreme due to the schools inappropriate location besides the airport. All teachers interviewed confirmed that it was necessary to interrupt their classes each time a plane lands or takes off. They also confirmed that with the windows fixed shut the classroom is stuffy with insufficient ventilation and high humidity. Whilst there exists possible new-build solutions to this problem the most effective and affordable solution would be to relocate the school, a solution that the local authorities are currently pursuing.

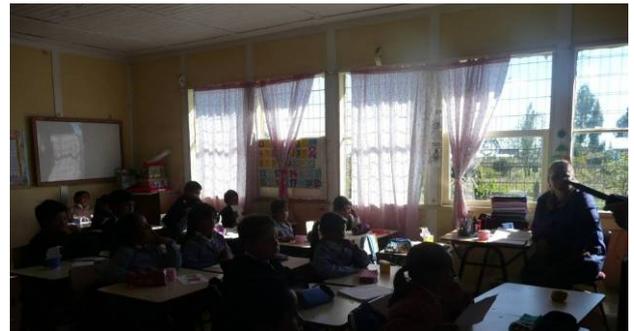
Figure 21. School F, Internal view of study classroom

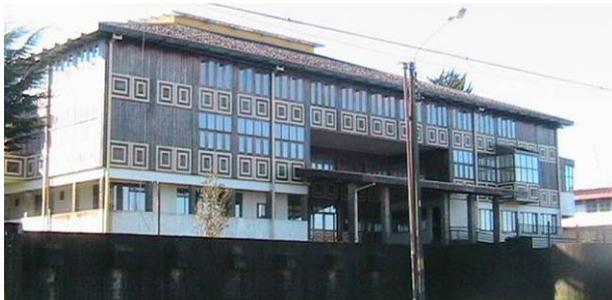
The school is situated near the seafront close to centre of town, with a central atrium with translucent roof. The classroom is situated on the second floor, facing east. The construction is reinforced concrete with pale yellow painted plaster internally. No external solar protection or internal curtains are provided. The artificial lighting consists of 8 fluorescent tubes, which are all switched off.

Figure 22. School G, External view

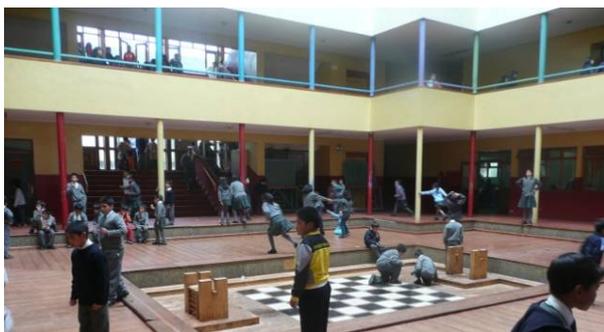
Figure 23. School G, Internal atrium

The central atrium provides a vibrant centre to the school and provides a well-lit protected space for recreation throughout the year. However the lack of acoustically absorbent materials in this space leads to poor acoustics and complaints by teachers.

The introduction of absorbent materials, such as acoustic wall or ceiling panels would help reduce the reverberation time of the space.

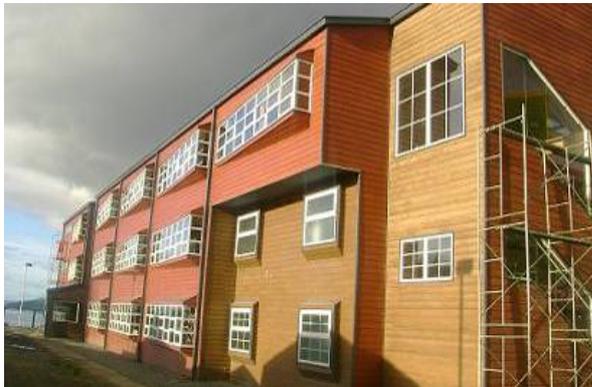
The school is recently constructed and is the only school studied with thermal insulation. It is situated in the upper part of the village overlooking the bay, with a central atrium. The classroom is situated first floor, facing east. The construction is timber framed with 100mm of insulation, clad internally and externally in timber. The room has glazing to the east and south. No external solar protection is provided with only internal curtains. The artificial lighting consists of 6 fittings each with 3 fluorescent tubes, which are all switched on.

Figure 24. School H, External view

The central atrium suffers similar acoustic problems as those encountered at school G. In addition the space suffers from complete lack of ventilation with no opening windows or mechanical ventilation, a problem also experienced in the kitchen and dining room of the school.

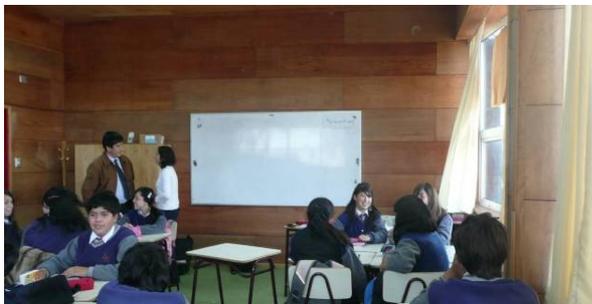
Figure 25. School H, Internal view of study classroom

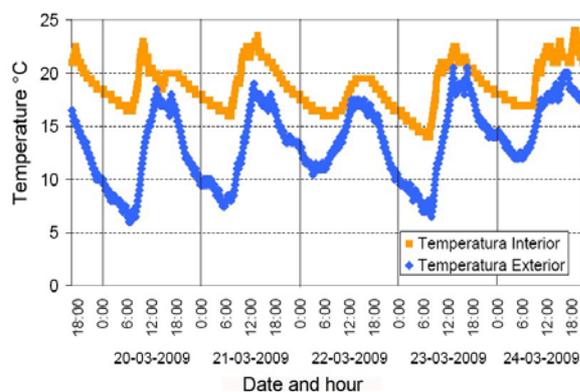
Figure 26. School H, Internal and external temperatures over a 6 day period

Being the only school in the study with an insulated building envelope it is not surprising to see that the indoor air temperature stays constantly above the external. Due to its recent completion the building manager and teachers have not yet experienced a winter in the building, however it is possible that the natural ventilation strategy of simple opening windows may prove problematic given the local climatic conditions.
