Participatory Evaluation of Performance in Public Buildings. The Case of Historic Buildings of the Ministry of Public Works, Chile.

Gabriela Armijo^{#1}, Eugenio Collados^{*2}, Patricio Bustamante^{*3}

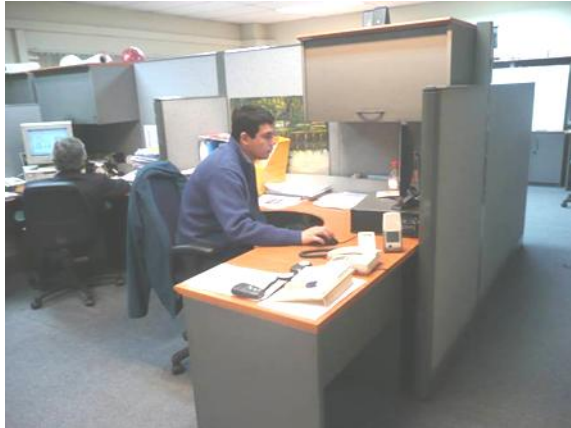
Figure 6: Example of illuminance and CO₂ sampling at desk level

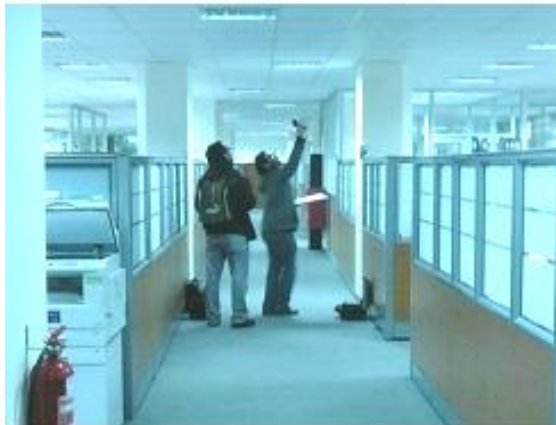
Cold spots and thermal bridges were looked for with infrared thermometers. Facades were also checked for unusual temperatures, thermal bridges and air infiltration.

Figure 7: Example of radiant temperature measurement.
